# Assessment and Recommendations for Improving the Performance of Waste Containment Systems

Rudolph Bonaparte, Ph.D., P.E.  
GeoSyntec Consultants  
Atlanta, GA 30342

EPA Cooperative Agreement Number  
CR-821448-01-0

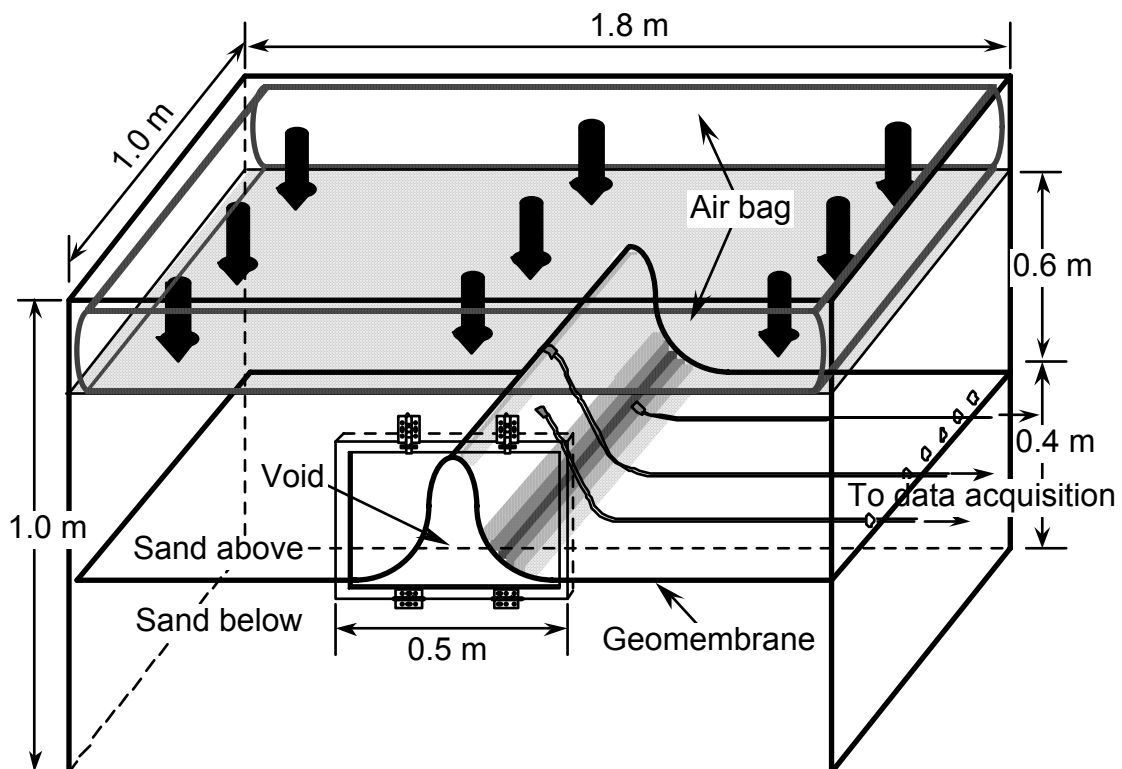
**Figure 2-5. Photograph and schematic illustration of the large-scale experimental test box used in wave study.**

- wave height decreased with increasing normal stress;
- an average reduction in wave heights of 40% was observed after 1,000 hours;
- GM thickness had a negligible effect on the decrease of wave height with normal stress;
- there was a slight decrease in wave height with increasing temperature;
- final wave heights were 5 to 47 mm; and
- intimate contact with the soil subgrade was never achieved.

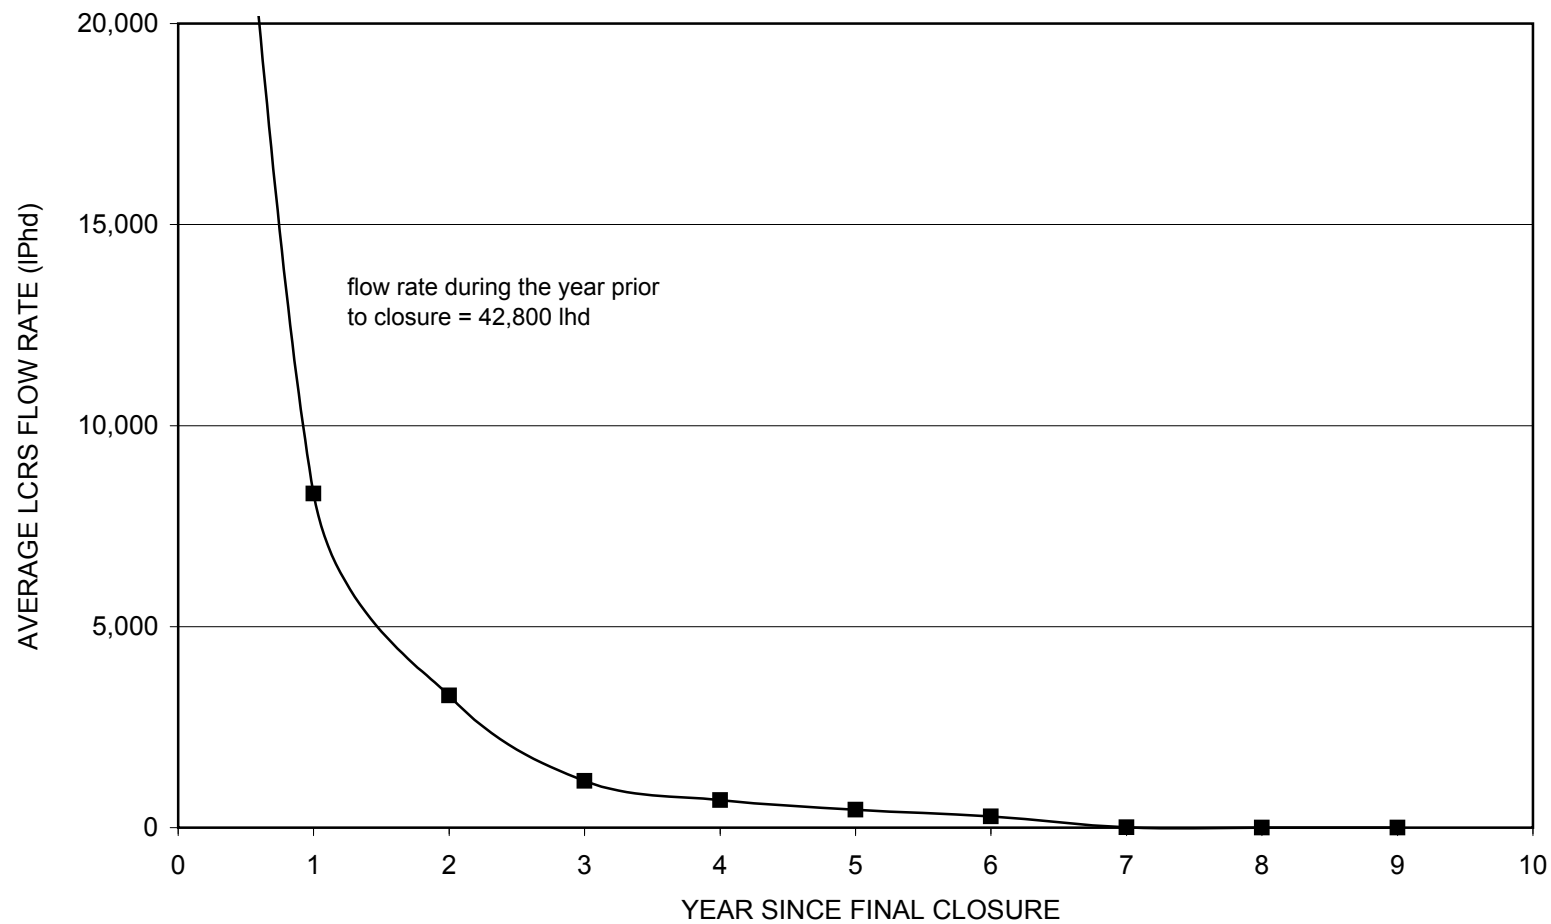
**Figure E-5.5. Average LCRS Flow Rates (lhd) After Closure of Cell AD5, a HW Cell Located in the SE.**
